**National Research
Council Canada**

CCMC 13023-R

*EVALUATION
REPORT*

Graftex®

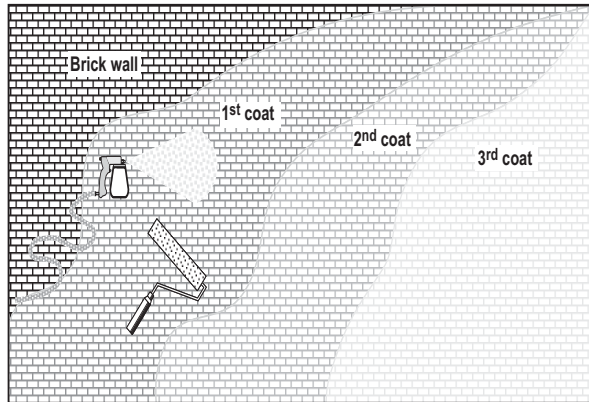
Figure 1 "Graftex®" Application Methods

"Graftex®" must be applied on damp surfaces in three coats, where each coat must be allowed to dry completely before the application of the following coats. Each coat is left to dry for 15 - 60 minutes before application of the next consecutive coat. (Depending on porosity of the substrate and the atmospheric conditions at time of application.) The expected coverage rate varies between 5 - 10 m²/l depending on the porosity of the substrate.
